# Risk-Informed Approach to Penstock Safety

NW Hydro Users Group September 25, 2012

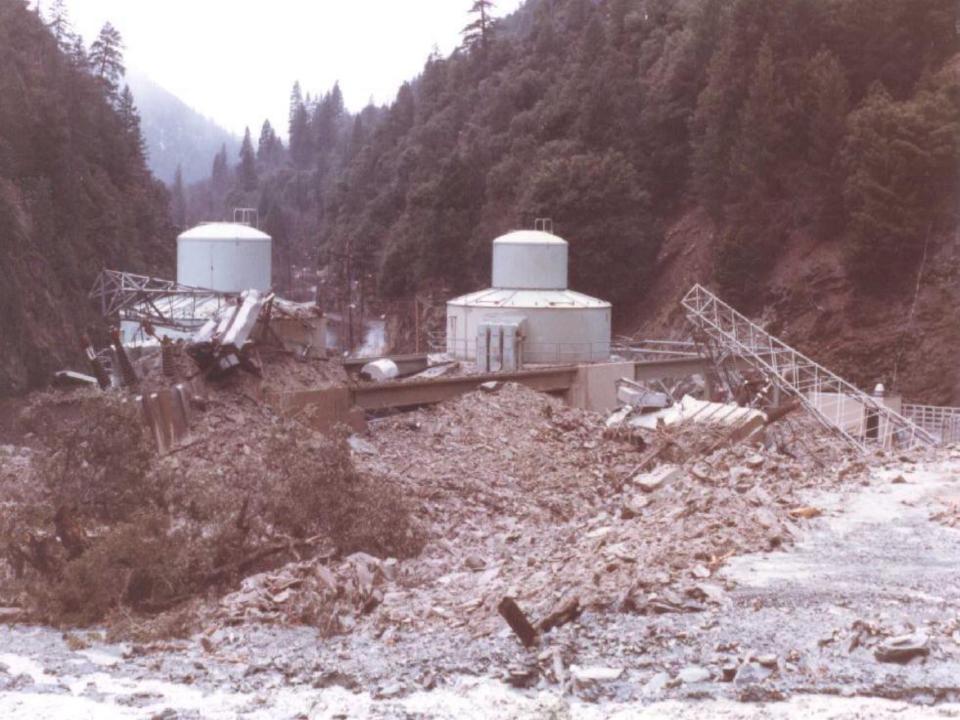
# Geotechnical/Geological

- Soil/Rock movement including landslides
- Rockfall
- Bearing failure

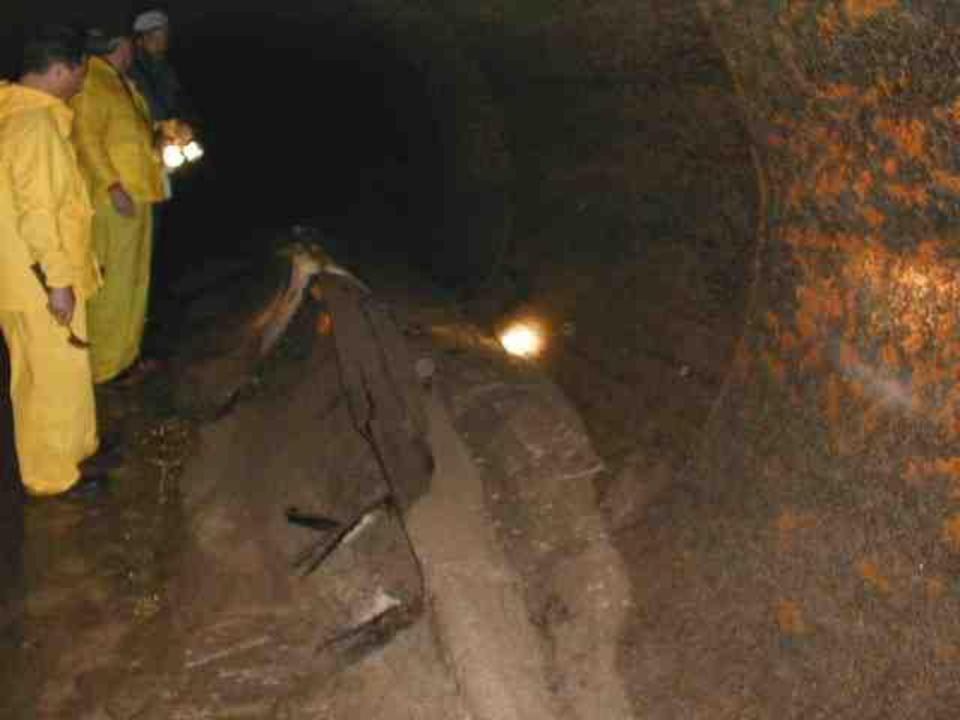
# Aging/Deterioration

- Lack of Maintenance
- Erosion of invert
- Stress-Corrosion Cracking
- Cavitation
- Acidic Soil
